ESTIMATION ANALYSIS
AND MAPPING OF
COASTAL OVERWASH ON KAUA'I
DURING THE LANDFALL OF
HURRICANE INIKI

C.H. Fletcher, I.T. Stewart,
T.A. Schroeder, G.M. Barnes,
B.M. Richmond, H.-J. Krock,
and D. Neill

October, 1993

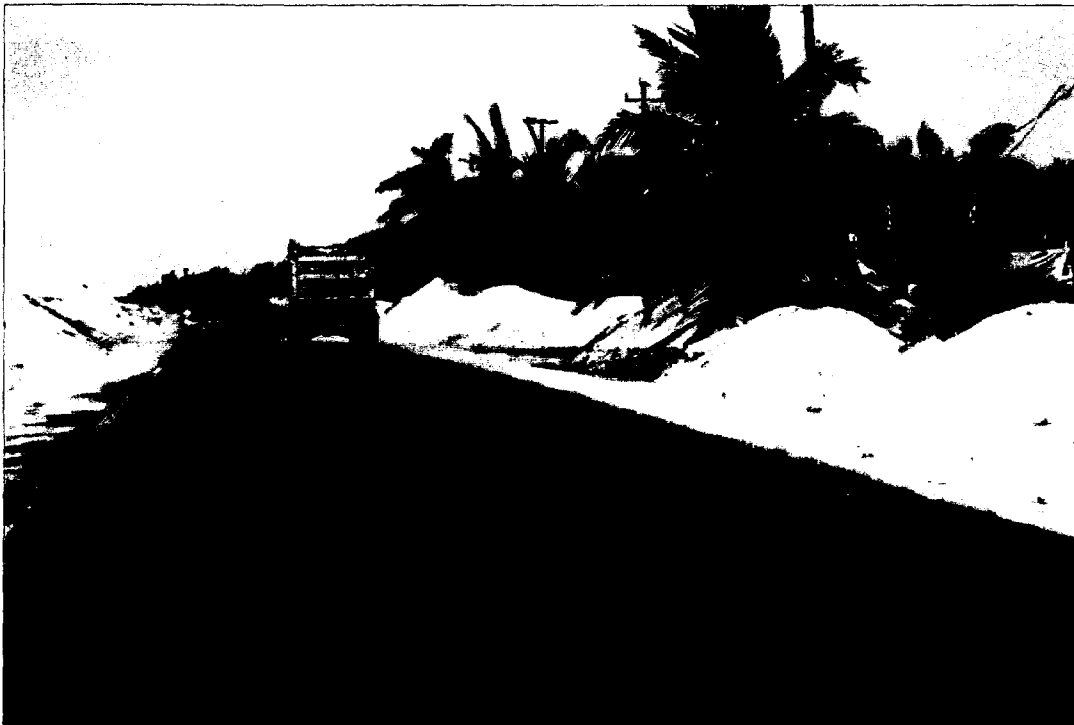
Figure 1. Overwashed and wind-blown sand on the coast road at Kekaha.

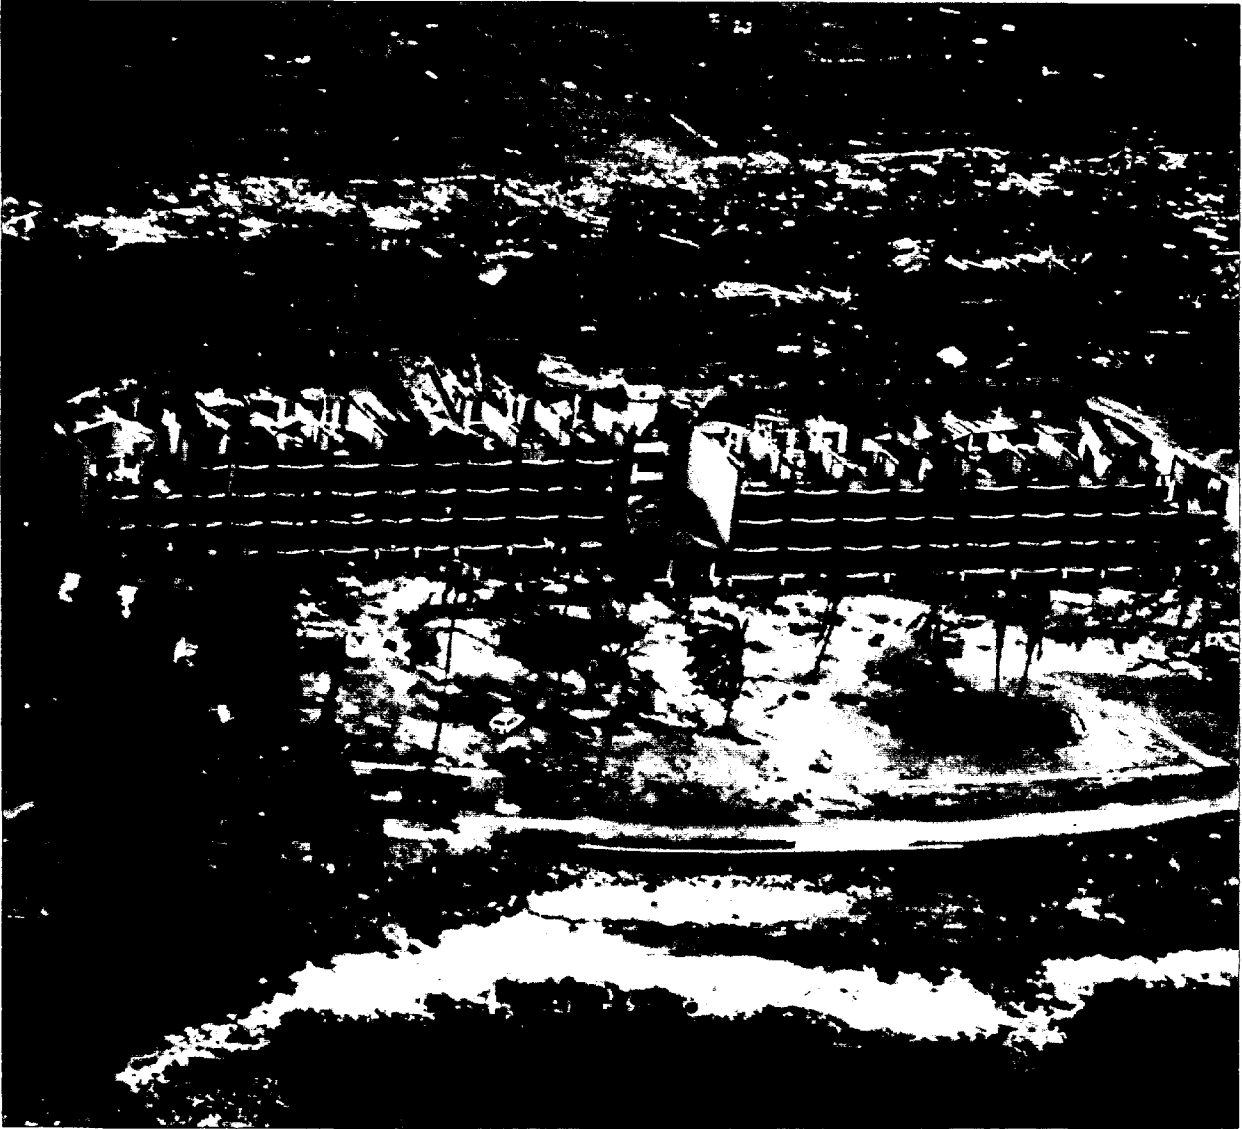
Figure 2. An 80 unit condominium complex, lower floors destroyed by overwash, upper floors destroyed by wind. Note the overwash debris line in the background. East of Kukuiula Bay, Kaua'i (see cover).

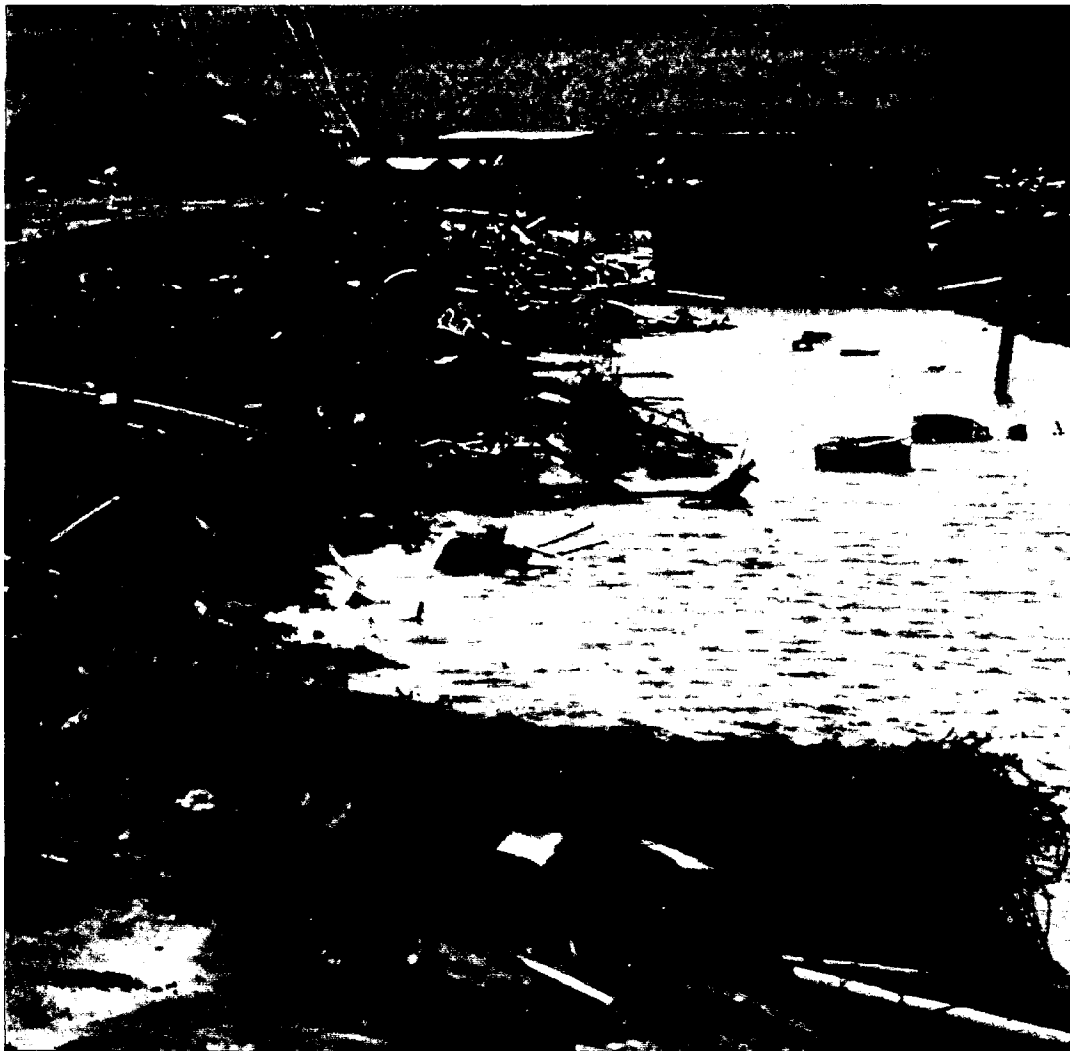
FIGURE 4. Houses in the Kukuiula Bay area, on the south coast of Kaua'i, were subjected to gusts reaching 64 m/sec and overwash reaching elevations 4.5 to 5.2 m. Houses were swept from their foundations and carried inland as much as 100 m by the inundation. Those buildings that remained in place were battered by boulders and debris carried in the raging sea, and flooded through their lower levels. Simultaneously, the wind ravaged the uppermost floors. Demolished structures along the waterline, such as seawalls, poured concrete lanai's, and paving stone acted as battering rams when carried by the overwash. Several homes sited on bluffs near Koloa landing were damaged by breaking waves reportedly exceeding 8 m in height.

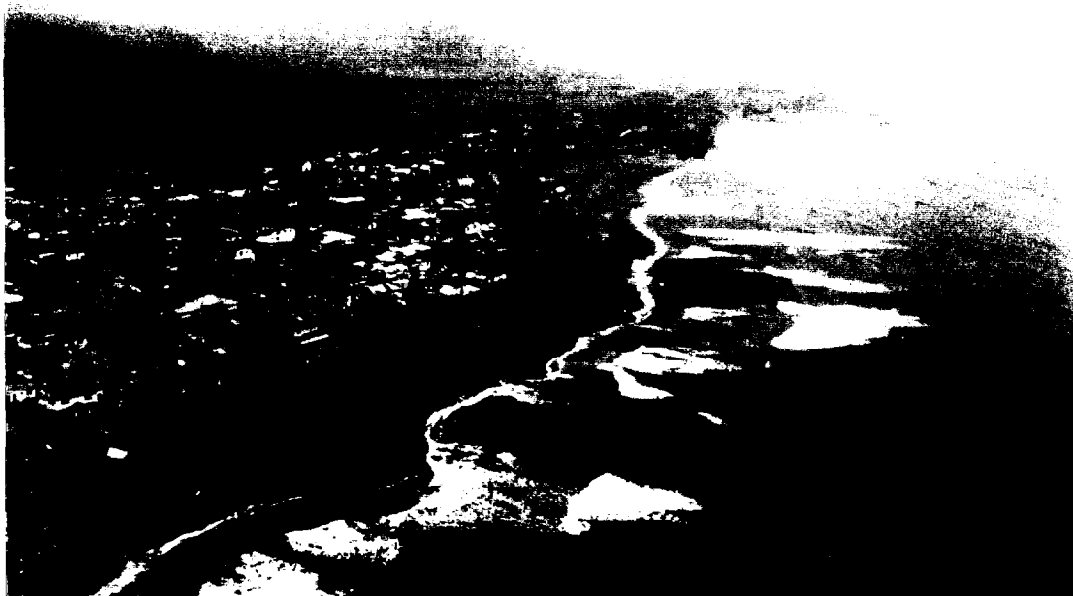
Figure 13. The end of the Kekaha revetment, and the erosional offset in the shoreline caused by Kikiaola Harbor in the distance.

The coast between Oomano Point and Kikiaola Harbor has undergone retreat at a rates of 0.15-0.6 m/yr (MOESE, 1992). Construction of the harbor in 1959 interrupted the net westward littoral drift and when erosion threatened the coast highway, the Kekaha revetment was built. Erosion continues west of the harbor, threatening the onshore stability of the west jetty which was flanked by overwash during Iniki. Flooding skirted, and partially eroded a dune system behind the west jetty and penetrated a local cemetery. Damage was minimal.

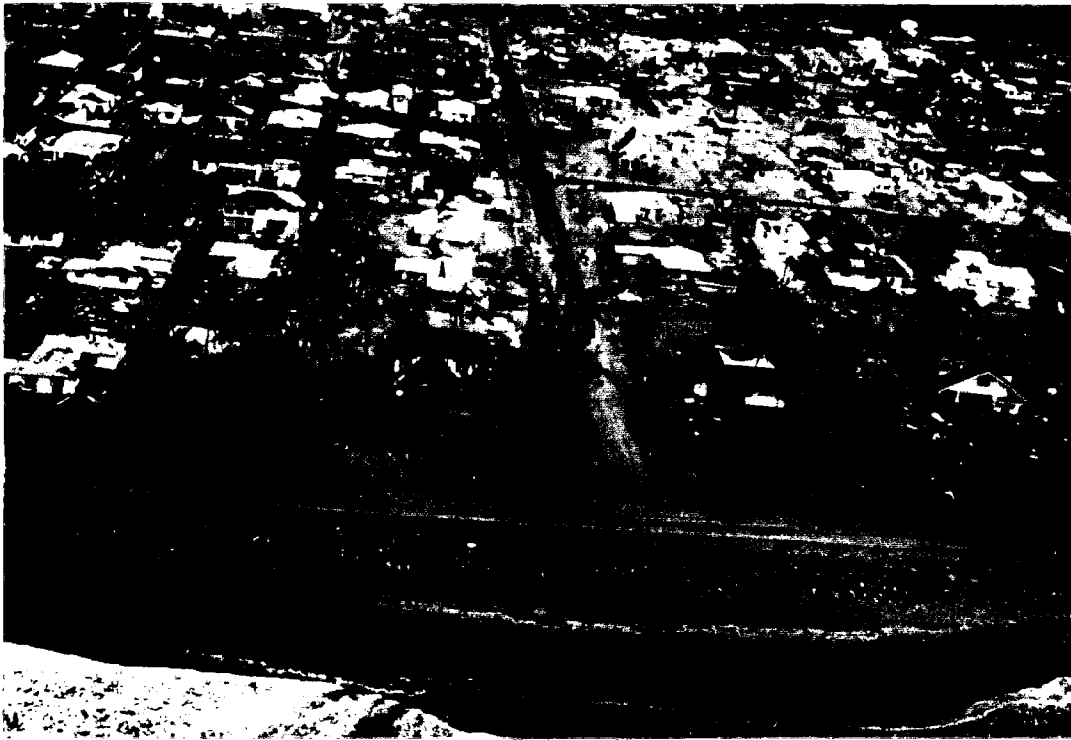
Figure 14. Overwash was channeled down coastal avenues, although velocity and total water volume was mitigated by the Kekaha revetment.

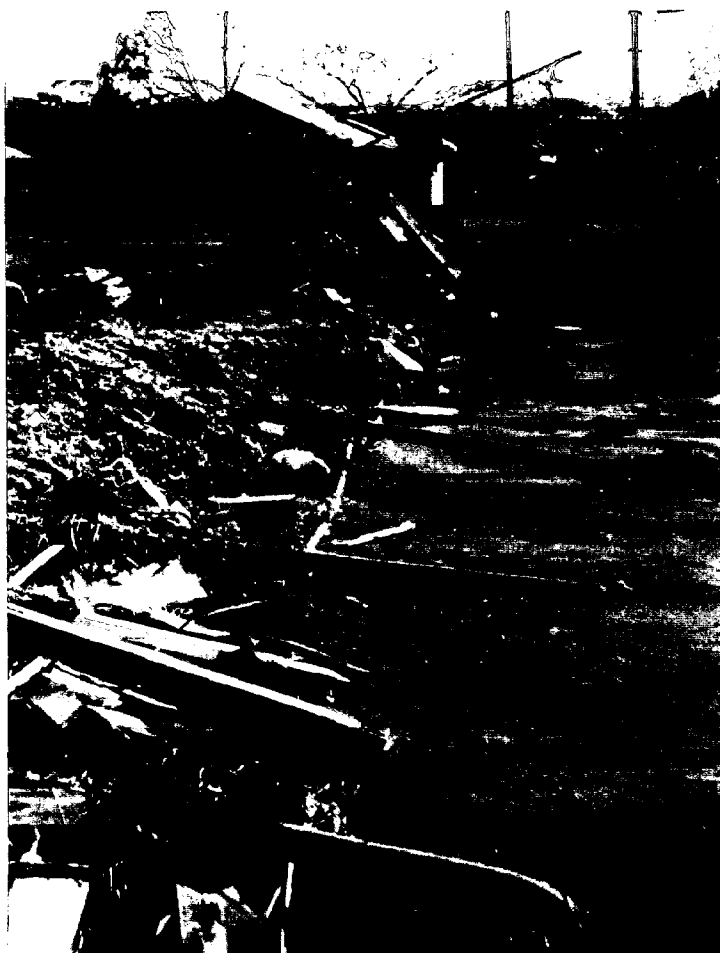
Figure 16. Overwash damage to a chain-link fence, Hanapepe Coastal Park.

Extensive damage to the coastal park in Hanapepe Bay occurred. A revetment was one source of large boulders that were carried in suspension by the overwash and destroyed park facilities including a bathing house and tennis court fencing. Soil erosion, evidenced by scarping of terrigenous deposits behind the revetment, led to high turbidity levels in the Bay.

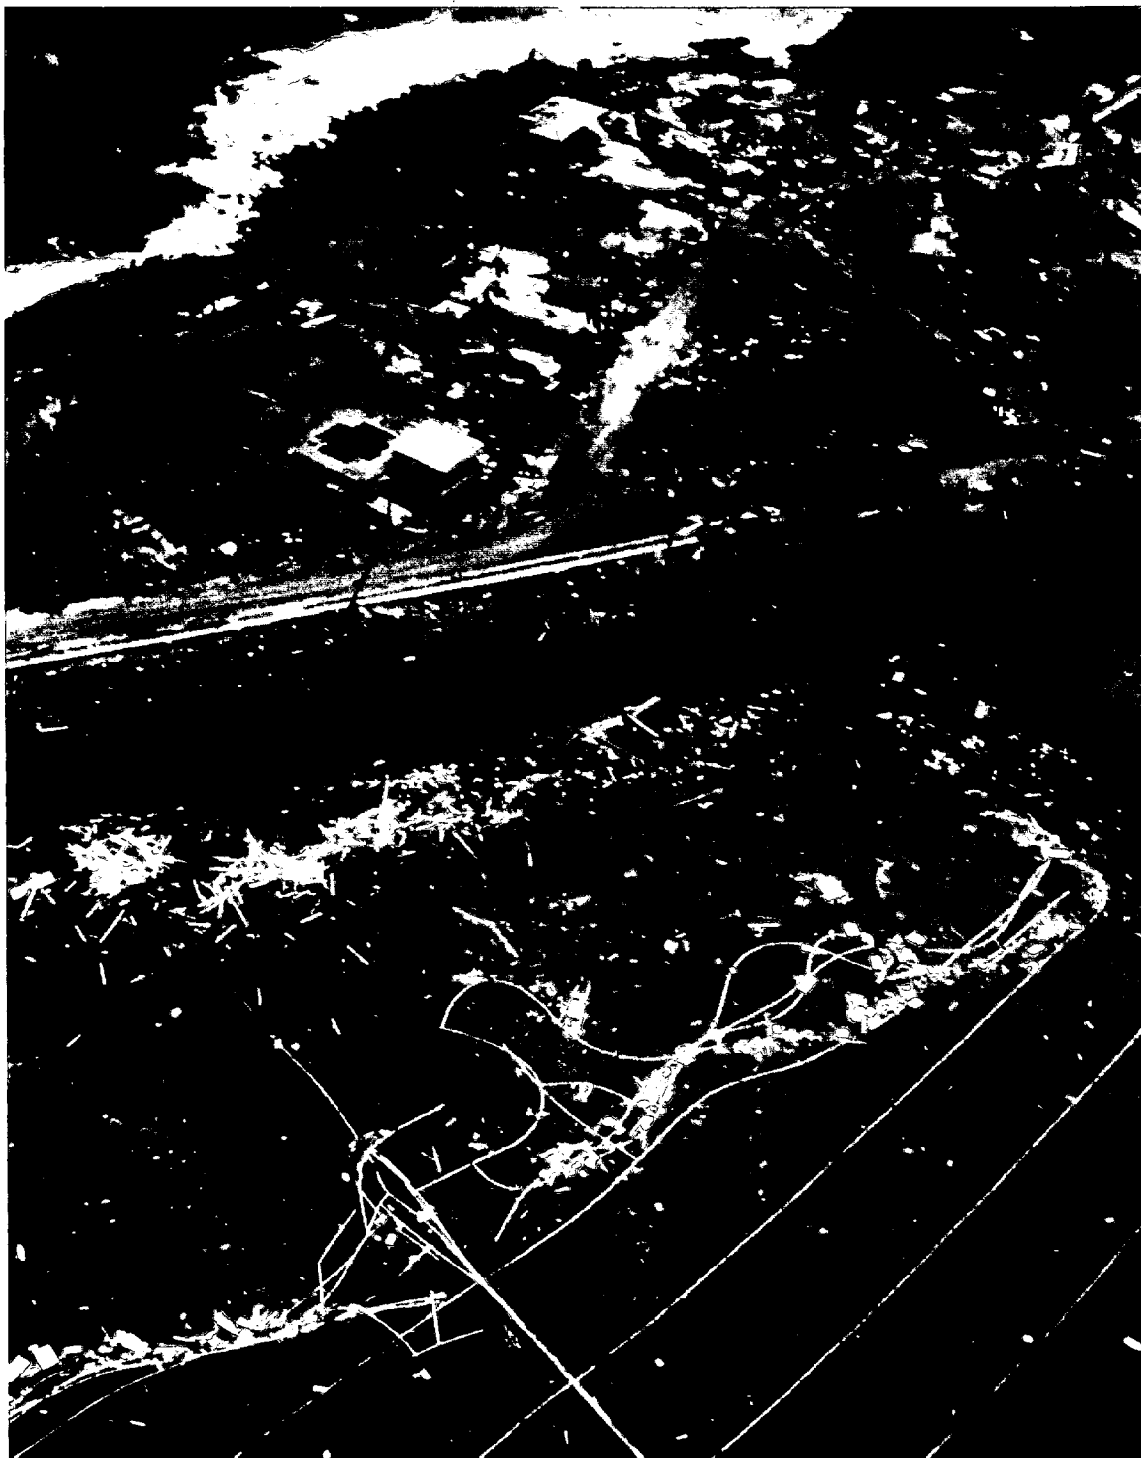
Figure 18. Overwash debris line near Kukuiula Bay.

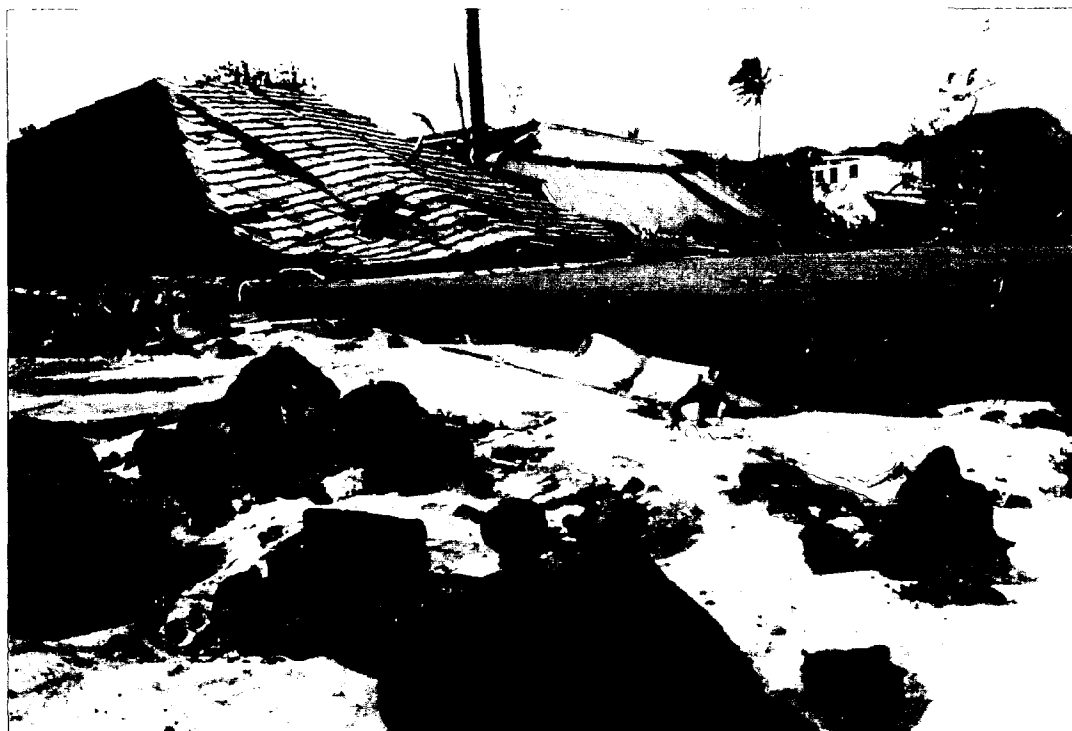
Figure 21. Coastal damage at Poipu Beach Park.

The seawall at this locality was damaged by Iniki, and this is an excellent opportunity to remove it completely in order to encourage beach recovery and long-term stability.

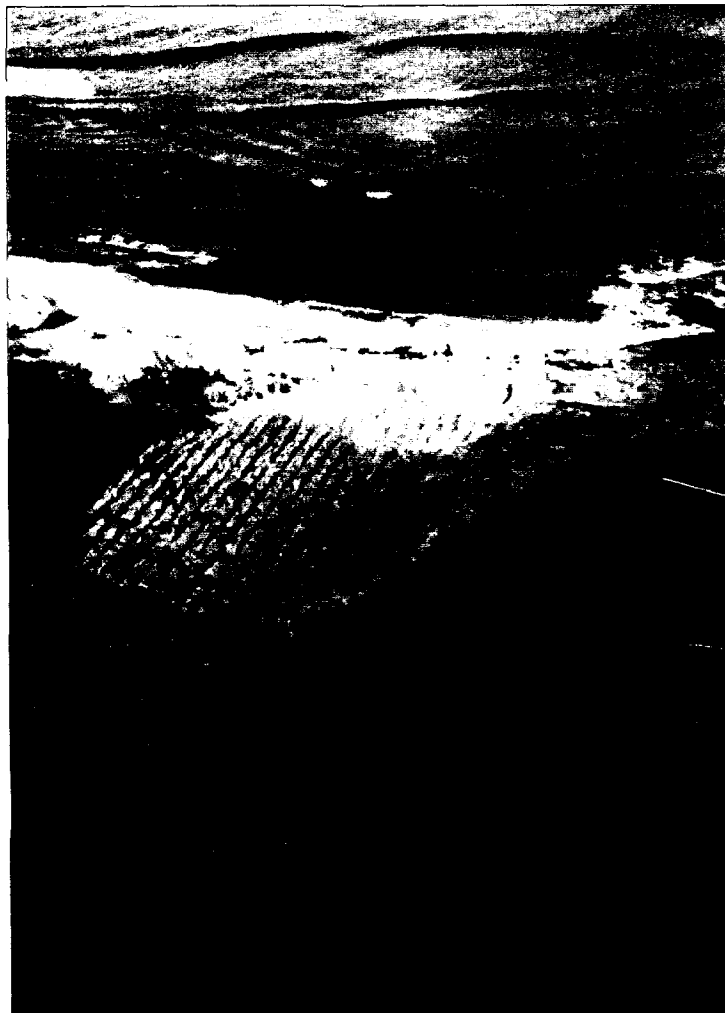
Figure 23. An overwash fan and dead sugar cane near Pakala Village.

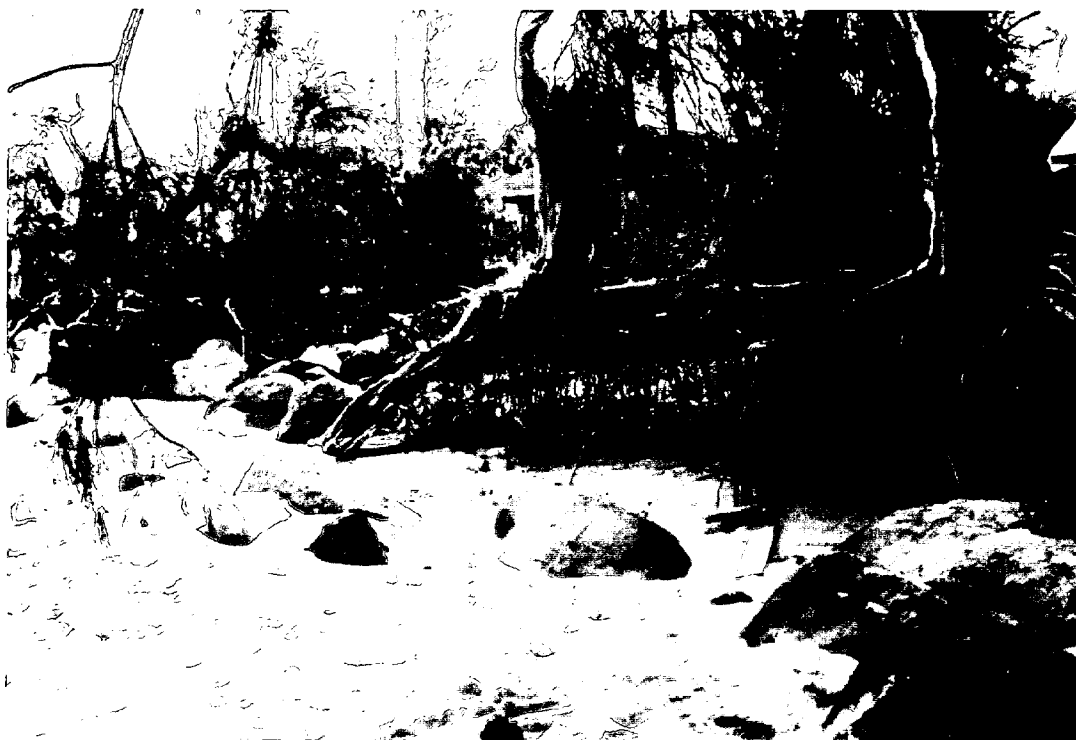
Figure 25. Top, erosion at Waipouli beach. Bottom, accretion at Mahaulepu.
